CARR ENGINEERING, INC.

RE: Manley v. FCA US, LLC

Pursuant to your request, I have reviewed information related to the Manley v. FCA case, which involves a February 16, 2017, alleged unintended acceleration of a 2011 Jeep Grand Cherokee with VIN 1J4RR6GT9BC620745 ("subject vehicle"). I have been asked to determine if the engine control electronics, including electronic throttle control ("ETC") and other related components and systems on the subject vehicle performed as designed prior to and during the incident. To evaluate the facts and circumstances surrounding this incident and to support my conclusions, I have inspected and tested the subject vehicle, reviewed photographs and test results from an exemplar vehicle, analyzed engineering and service documents, reviewed crash scene photographs, police and fire reports, vehicle records, and other relevant materials. I have applied scientific methodology and electrical engineering principles in my analysis. Appendix 1 contains a list of materials I have reviewed.

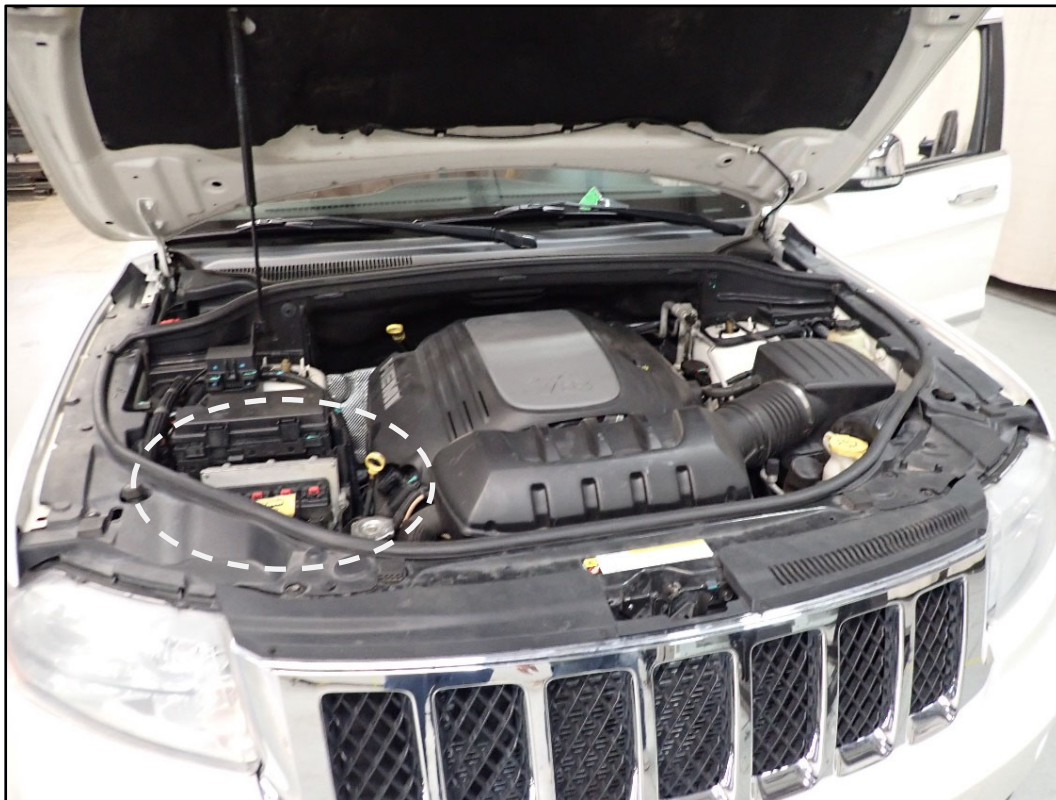
Figure 5 – Photograph of the PCM in the front passenger-side area of the engine compartment. The PCM has red tabs on the connectors. (P3221296.JPG)

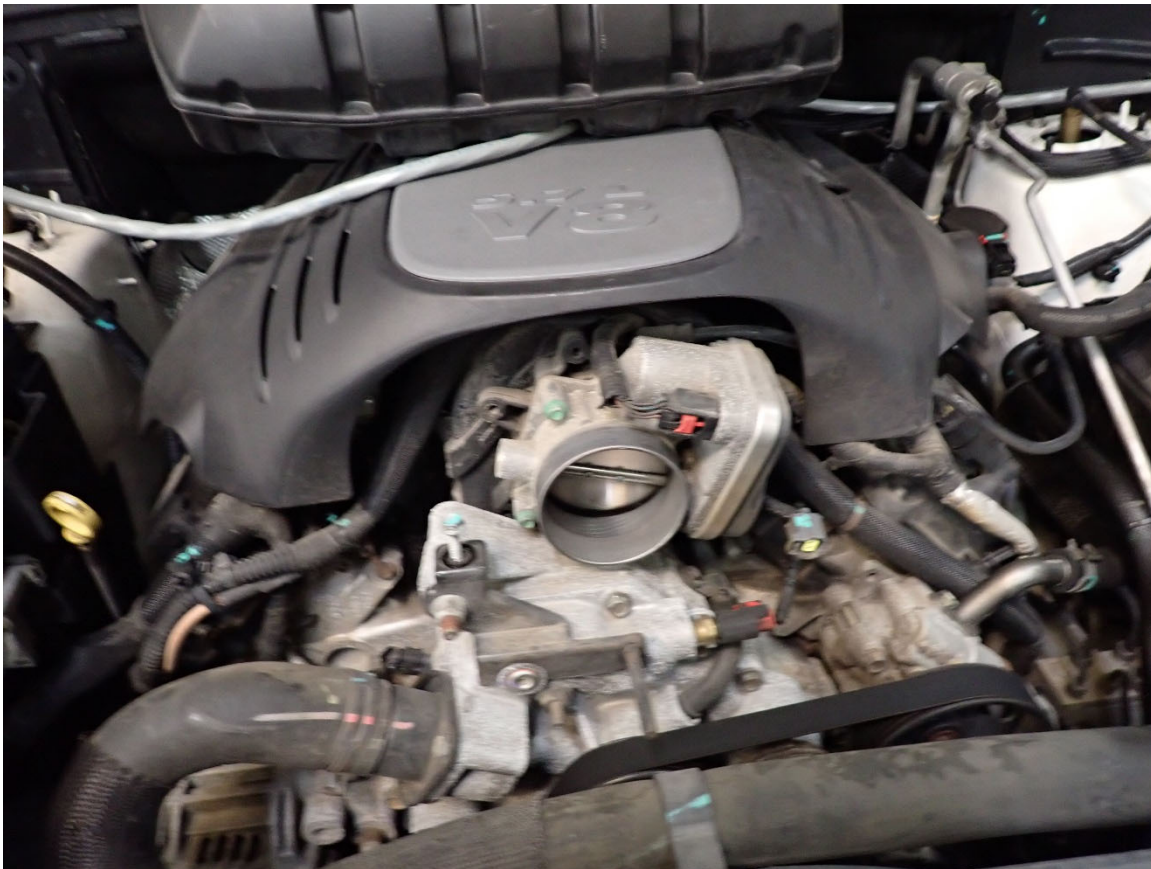
Figure 6 – Photograph showing the engine compartment with components removed for access to the throttle body. (P3231303.JPG)

The resistances between individual circuits were measured with the throttle body in the idle and wide-open throttle positions. The TPS circuits were powered with 5 VDC and the circuit voltages were measured for the idle and wide-open throttle positions. A voltage sweep was performed on

the throttle body assuring that the signals varied smoothly and without gaps. The test results for the exemplar vehicle TPS were within specification.

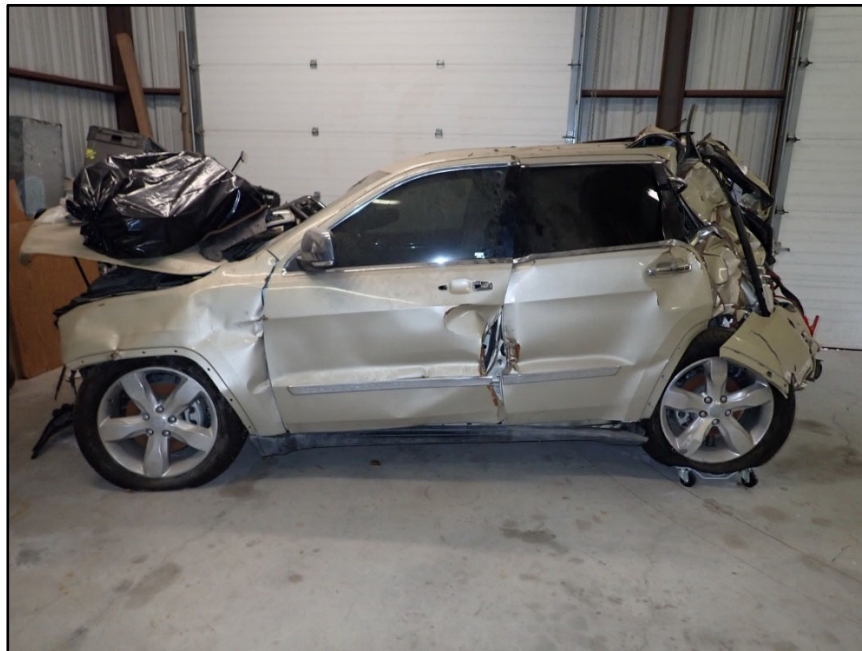
Figure 7 – Photograph 8434_a003.JPG shows a side view of the subject vehicle.

Visual inspection of the subject vehicle showed that the electronic digital odometer was unreadable due to crash damage, that the ORC (Occupant Restraint Controller) had been accessed and imaged, and there were no abnormal conditions observed when the braking system components were inspected. The brake fluid level was normal and the brake pedal firmness was observed to be

normal when the pedal was depressed. The master cylinder appeared to be in normal condition with the reservoir intact. There were no significant fluid leaks observed. The vehicle tires were also observed to have sufficient tread depth and were in good condition unless damaged in the crash.

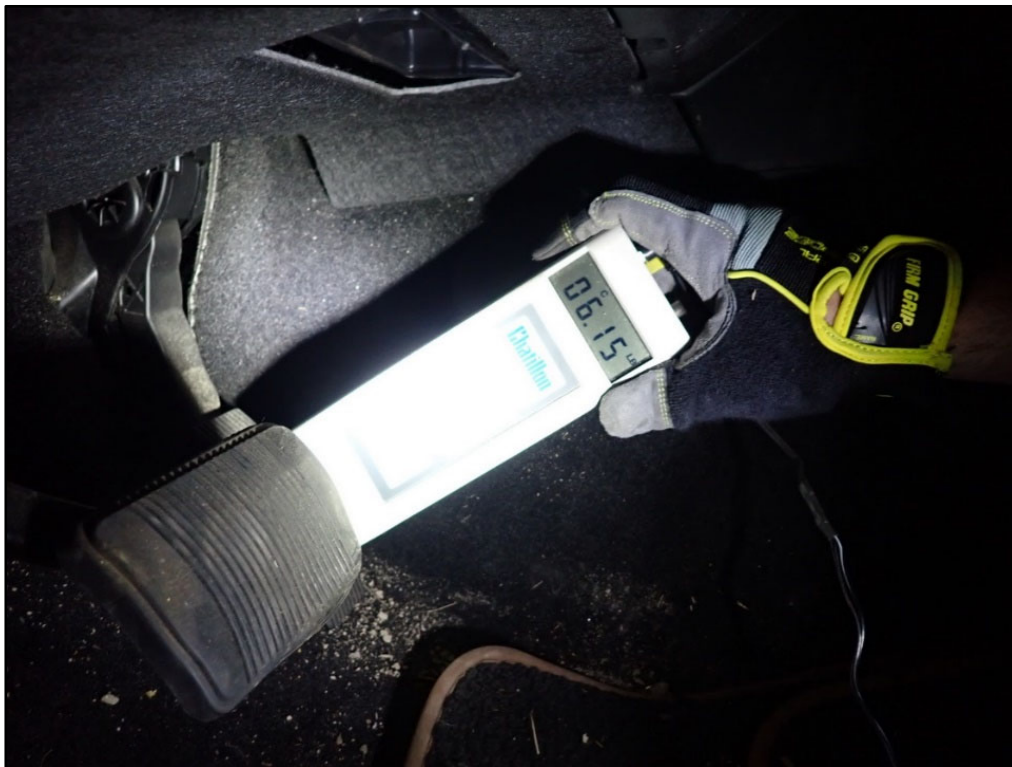
The brake pedal and driver footwell area were inspected and found to be in normal condition and free of noticeable distortion or bends. The accelerator pedal supporting vehicle structure were found to be in normal condition, free of bends. The accelerator pedal moved smoothly when actuated by hand and quickly returned to the idle or rest position when no force was applied. The force required to operate the accelerator pedal was approximately six pounds when applied to the center of the pedal pad with a handheld force gauge as shown in Figure 8.

Figure 8 – Photograph 8434_a118.JPG showing the pedal force measurements taken with a handheld force meter.

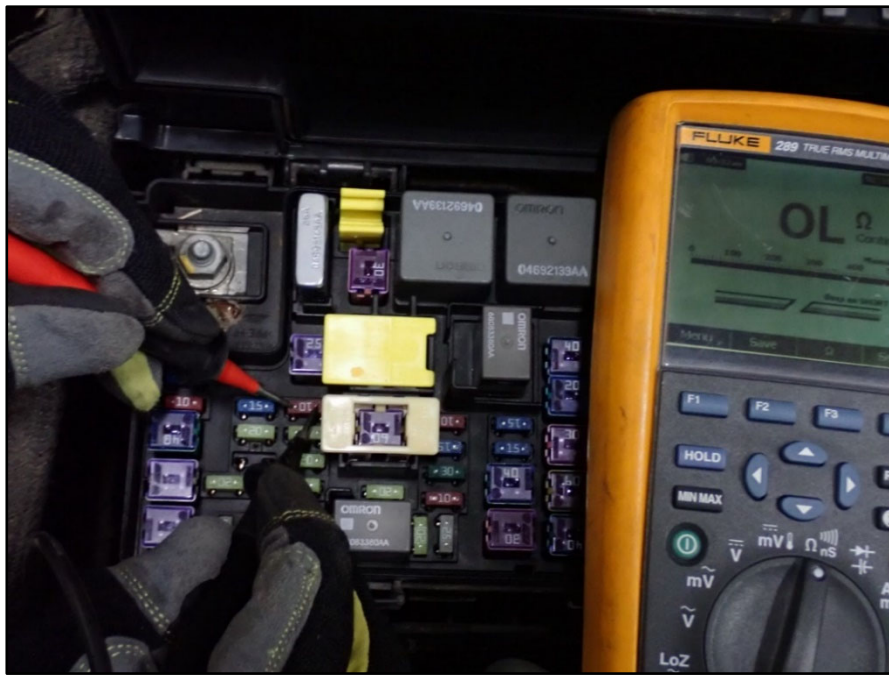
Underhood fuses were checked and tested good either by continuity or visual inspection, with the only exception being fuse M4 (10A) "Trailer Tow," which was found to be open. This measurement is shown in Figure 9.

Figure 9 – Photograph 8434_a185.JPG showing the open Trailer Tow fuse testing.

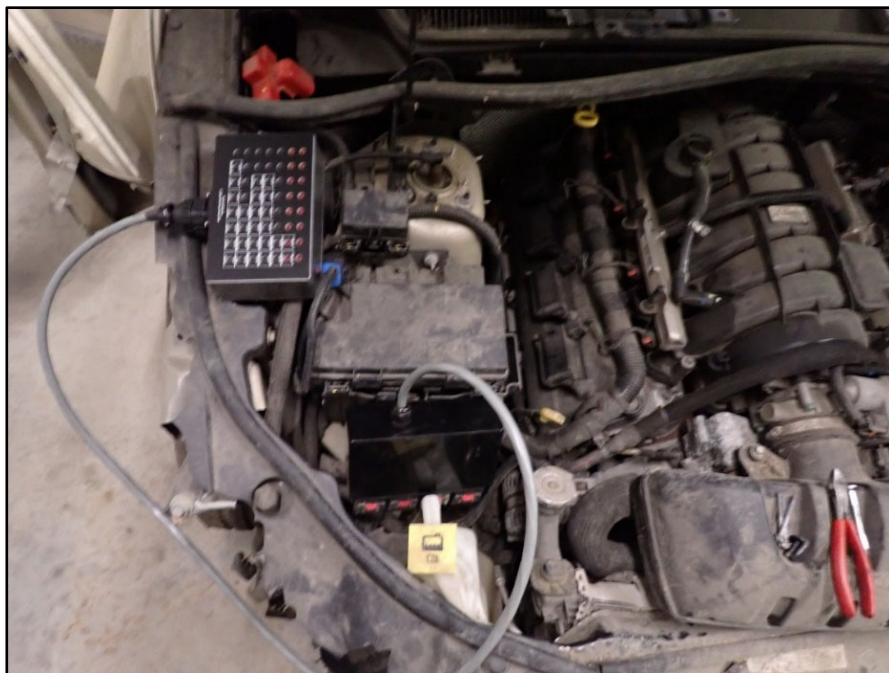
The four connectors were removed from the PCM (Powertrain Control Module) and the breakout box was installed as shown in Figure 10.

Figure 10 – Photograph 8434_a171.JPG showing the breakout box connected to the PCM.

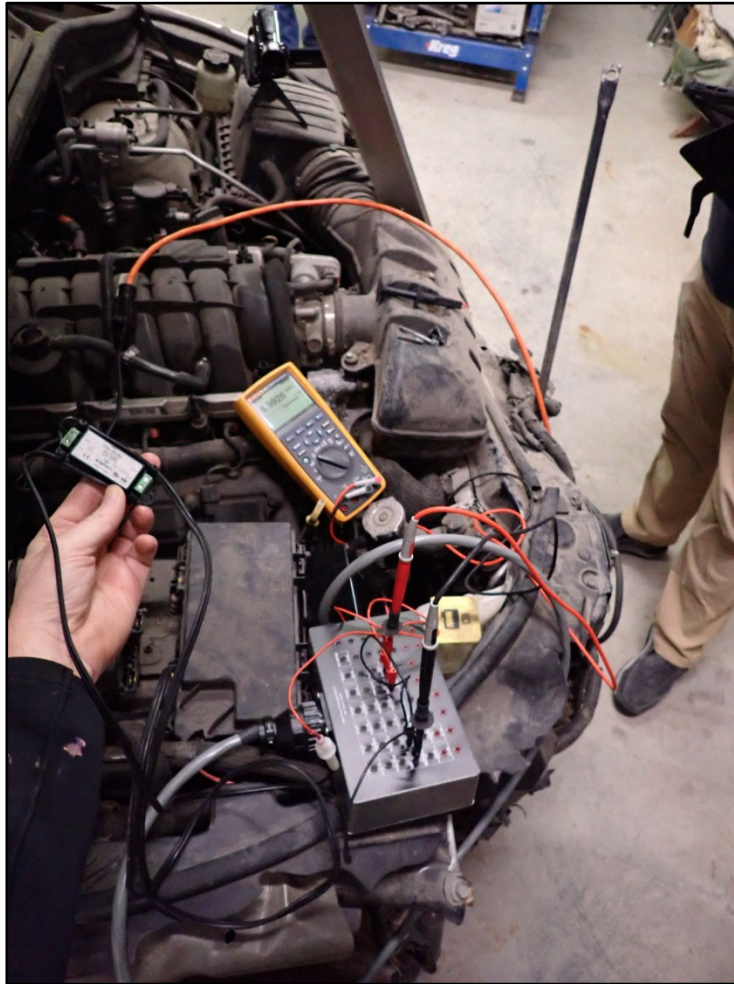
First, circuit resistance measurements similar to those described above for the exemplar vehicle were taken and recorded. For these measurements, every circuit is compared to every other circuit to detect circuit shorts and opens for each component. Active measurements are then made of certain components (APPS, TPS, and brake/stop lamp switch) by attaching a regulated, current limited, power supply to each component through the breakout box.

Figure 11 – Photo 8343_a188.JPG shows the regulated 5 VDC power supply used to energize the throttle valve and accelerator pedal position sensors during the subject vehicle inspection.

All of the resistance and voltage measurements taken during the inspection were as per vehicle specifications, other than the open fuse mentioned earlier. These same resistance and voltage measurements are next compared to results from an exemplar or substantially similar vehicle.

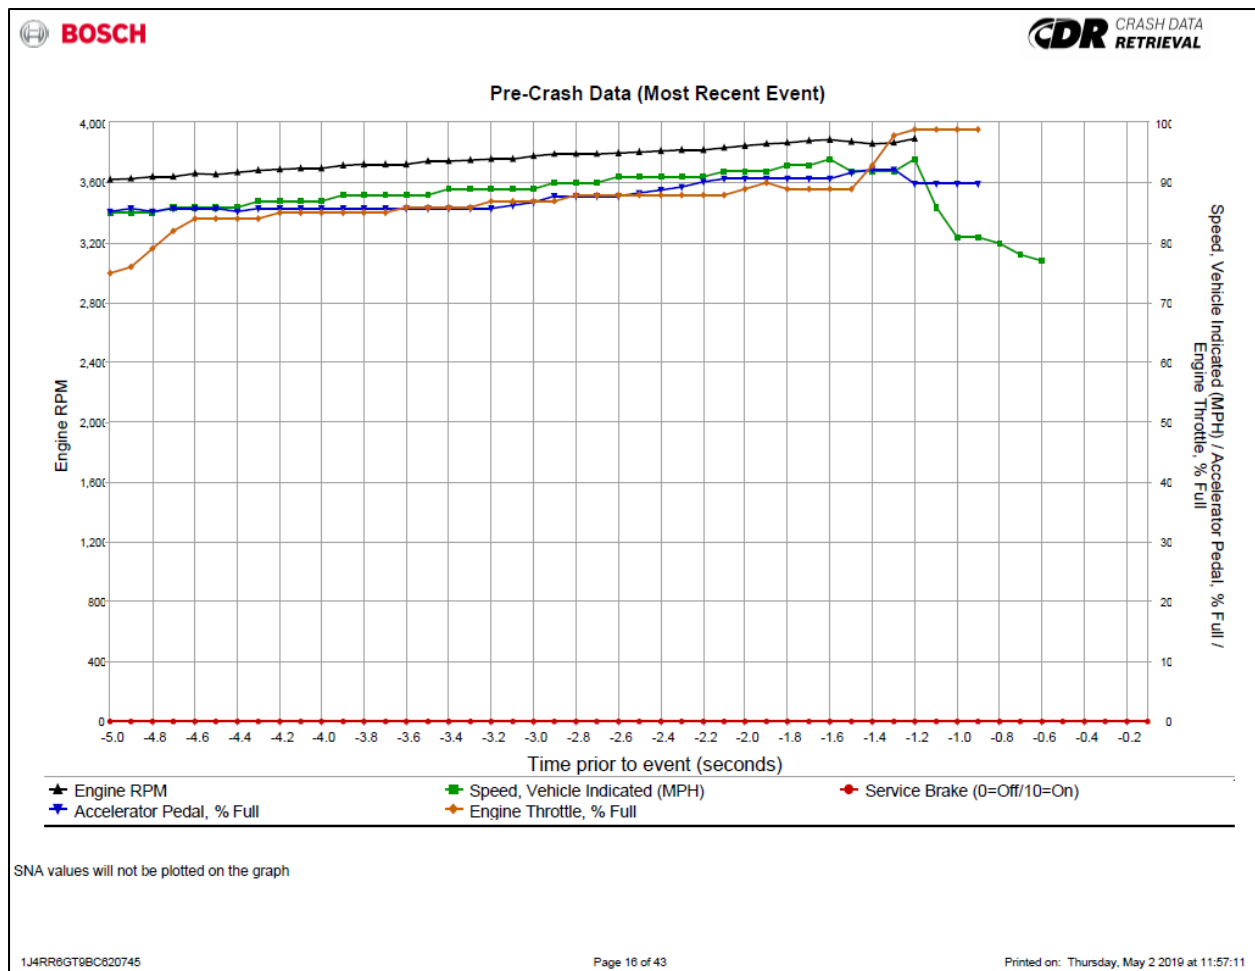
The CDR report from the February 16, 2017 Manley crash shows that two events were recorded. The pre-crash data show that prior to the first recorded event, the brake pedal was not applied, as represented by the red line at "0" in Figure 16. This chart also shows that Mr. Manley was applying the accelerator pedal as shown by the blue line in Figure 16. The CDR pre-crash data represent a reliable, objective record of driver actions in the seconds before a crash.

Figure 16 – Pre-Crash Data from the CDR Crash Retrieval file for the subject vehicle (VIN 1J4RR6GT9BC620745).

- On February 16, 2017, the subject 2011 Jeep Grand Cherokee responded to the driver's commands and performed as designed, as confirmed by the CDR report. The cause of the subject crash was the driver, not the vehicle.
